AVIATION INVESTIGATION REPORT

A04Q0049

RUNWAY EXCURSION

BEECHCRAFT A100 C-FMAI

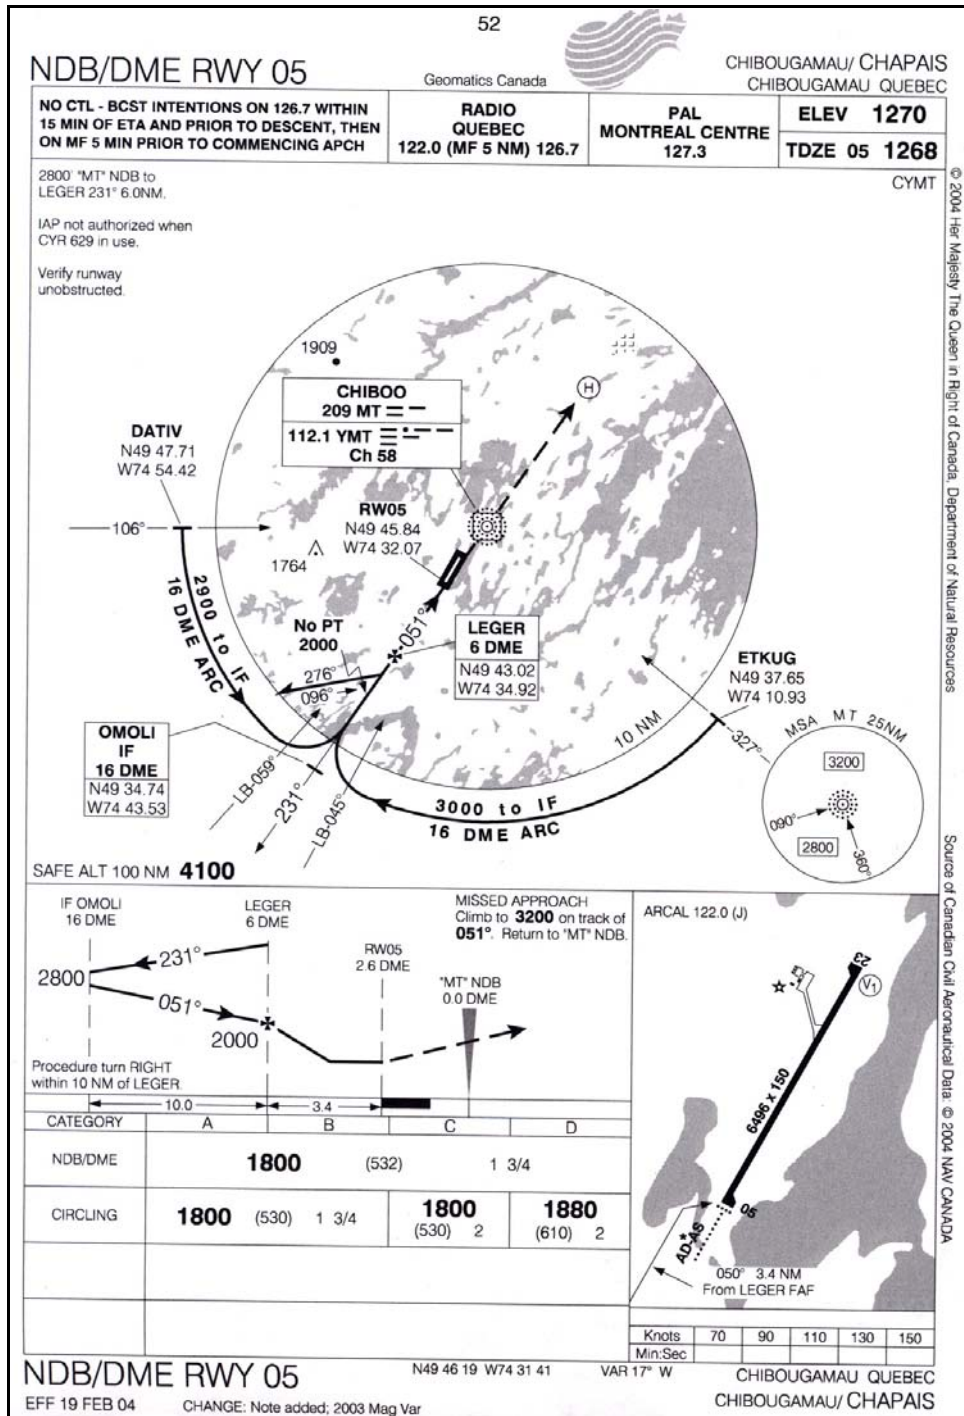
Appendix A – NDB/DME Approach for Runway 05

In accordance with the CARs, the pilot-in-command of C-FMAI decided to avoid the other aircraft by heading for OMOLI, the intermediate approach fix for Runway 05, to fly a holding pattern and let the other aircraft land. The pilot-in-command also decided to fly the non-directional beacon/distance measuring equipment (NDB/DME) approach for Runway 05 instead of an approach for Runway 23. C-FMAI flew over OMOLI at an approximate altitude of 3000 feet above sea level (asl), which could have contributed to a loss of separation or even a collision in the event that the other aircraft, which was approaching in the opposite direction, executed a missed approach that required it to climb to 3200 feet on a heading of 237 degrees, which is in the general direction of OMOLI, before heading for beacon MT.

The minimum descent altitude (MDA) published for the NDB/DME approach for Runway 05 is established at 1800 feet asl, or 532 feet agl and visibility 1 ¾ miles. Even though the ceiling was below the minimum published for an instrument approach during the approach, there were no regulations prohibiting the flight crew from executing the approach. With regard to landing, the existing regulations prohibit the pilot of an aircraft on an instrument approach from continuing the descent below the MDA if he or she has not established and maintained the visual reference required to carry out a safe landing. In that case, he must execute a missed approach.

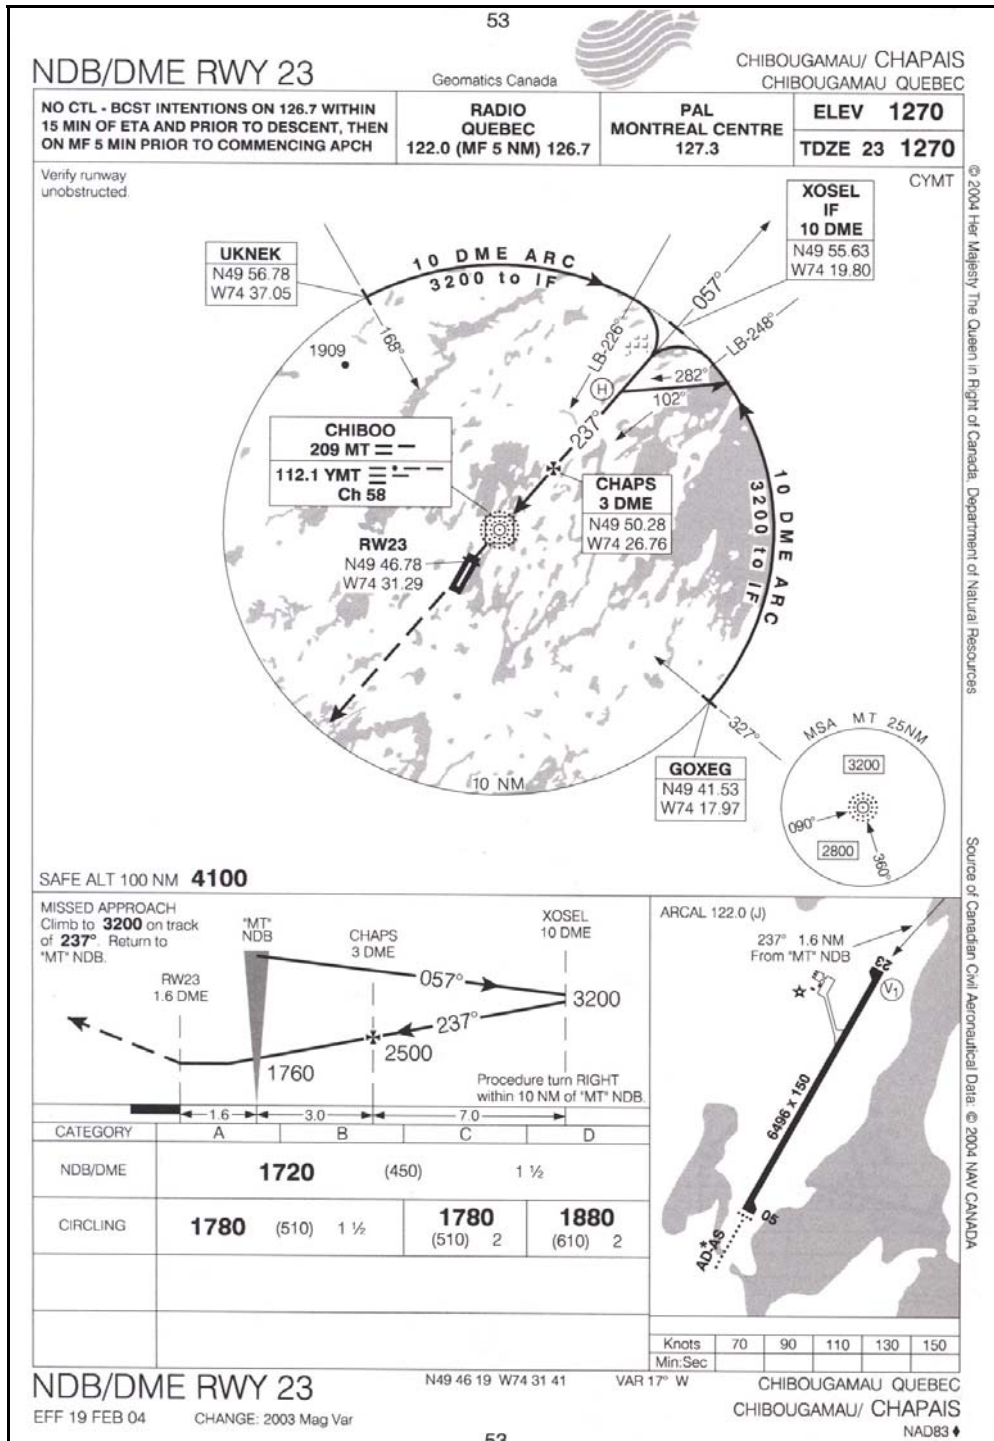
Appendix B – NDB/DME Approach for Runway 23

Not being aware that the weather had deteriorated, the crew of C-FMAI probably believed that the other aircraft would land without difficulty and there would be no conflict. As for the decision to fly an approach for Runway 05 instead of for Runway 23, its motivation may have been to save time. That decision increased the risk to which the flight was exposed by landing with a tailwind component on a wet runway, in addition to placing it on an opposing path to the other traffic approaching for Runway 23.
